Townscape Appraisal

Whatton

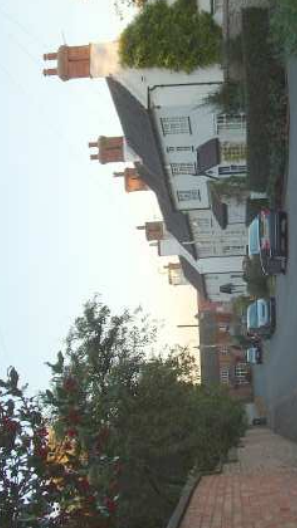
1 Row of cottages opposite the church are typical of the village and create a strong sense of place. The continuity of features such as chimney stacks, traditional windows, slate roofs and whitewashed walls create an attractive streetscape with a strong rhythm.

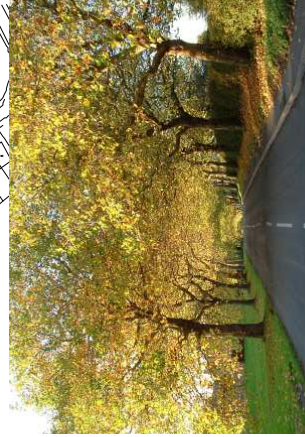
2 This stretch of Crantham Road has a formal landscape. The uniformly planted trees line the street and create a dramatic archway.

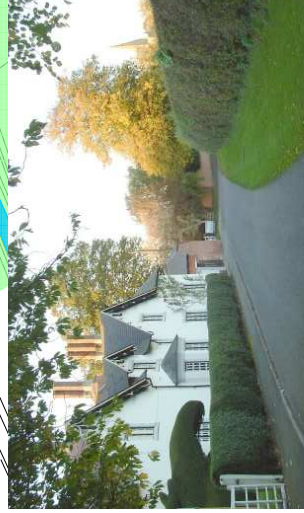
3 View along Church Street. The hedgerows and grass verge without kerbstones create a rural character. The positive building on the left, with its many original features and proximity to the street, makes a major contribution to the special character of the conservation area.

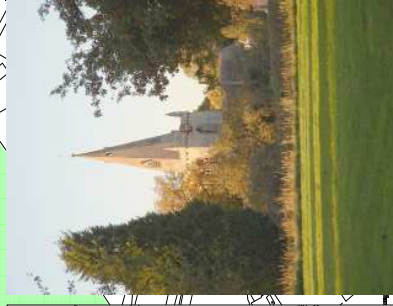
4 View of the church across one of the key open spaces in the village. These open spaces have a strong rural character and their location in the centre of the settlement is particularly distinctive.
